**Subject: Analysis of Brownfields Cleanup Alternatives  
Mayview School Site, Mayview, Missouri  
Missouri Environmental Assessment Services Contract, Contract No. C312021002  
Vendor No. 48120656000**

**ANALYSIS OF BROWNFIELDS CLEANUP ALTERNATIVES**

**MAYVIEW SCHOOL SITE, MAYVIEW, MISSOURI**

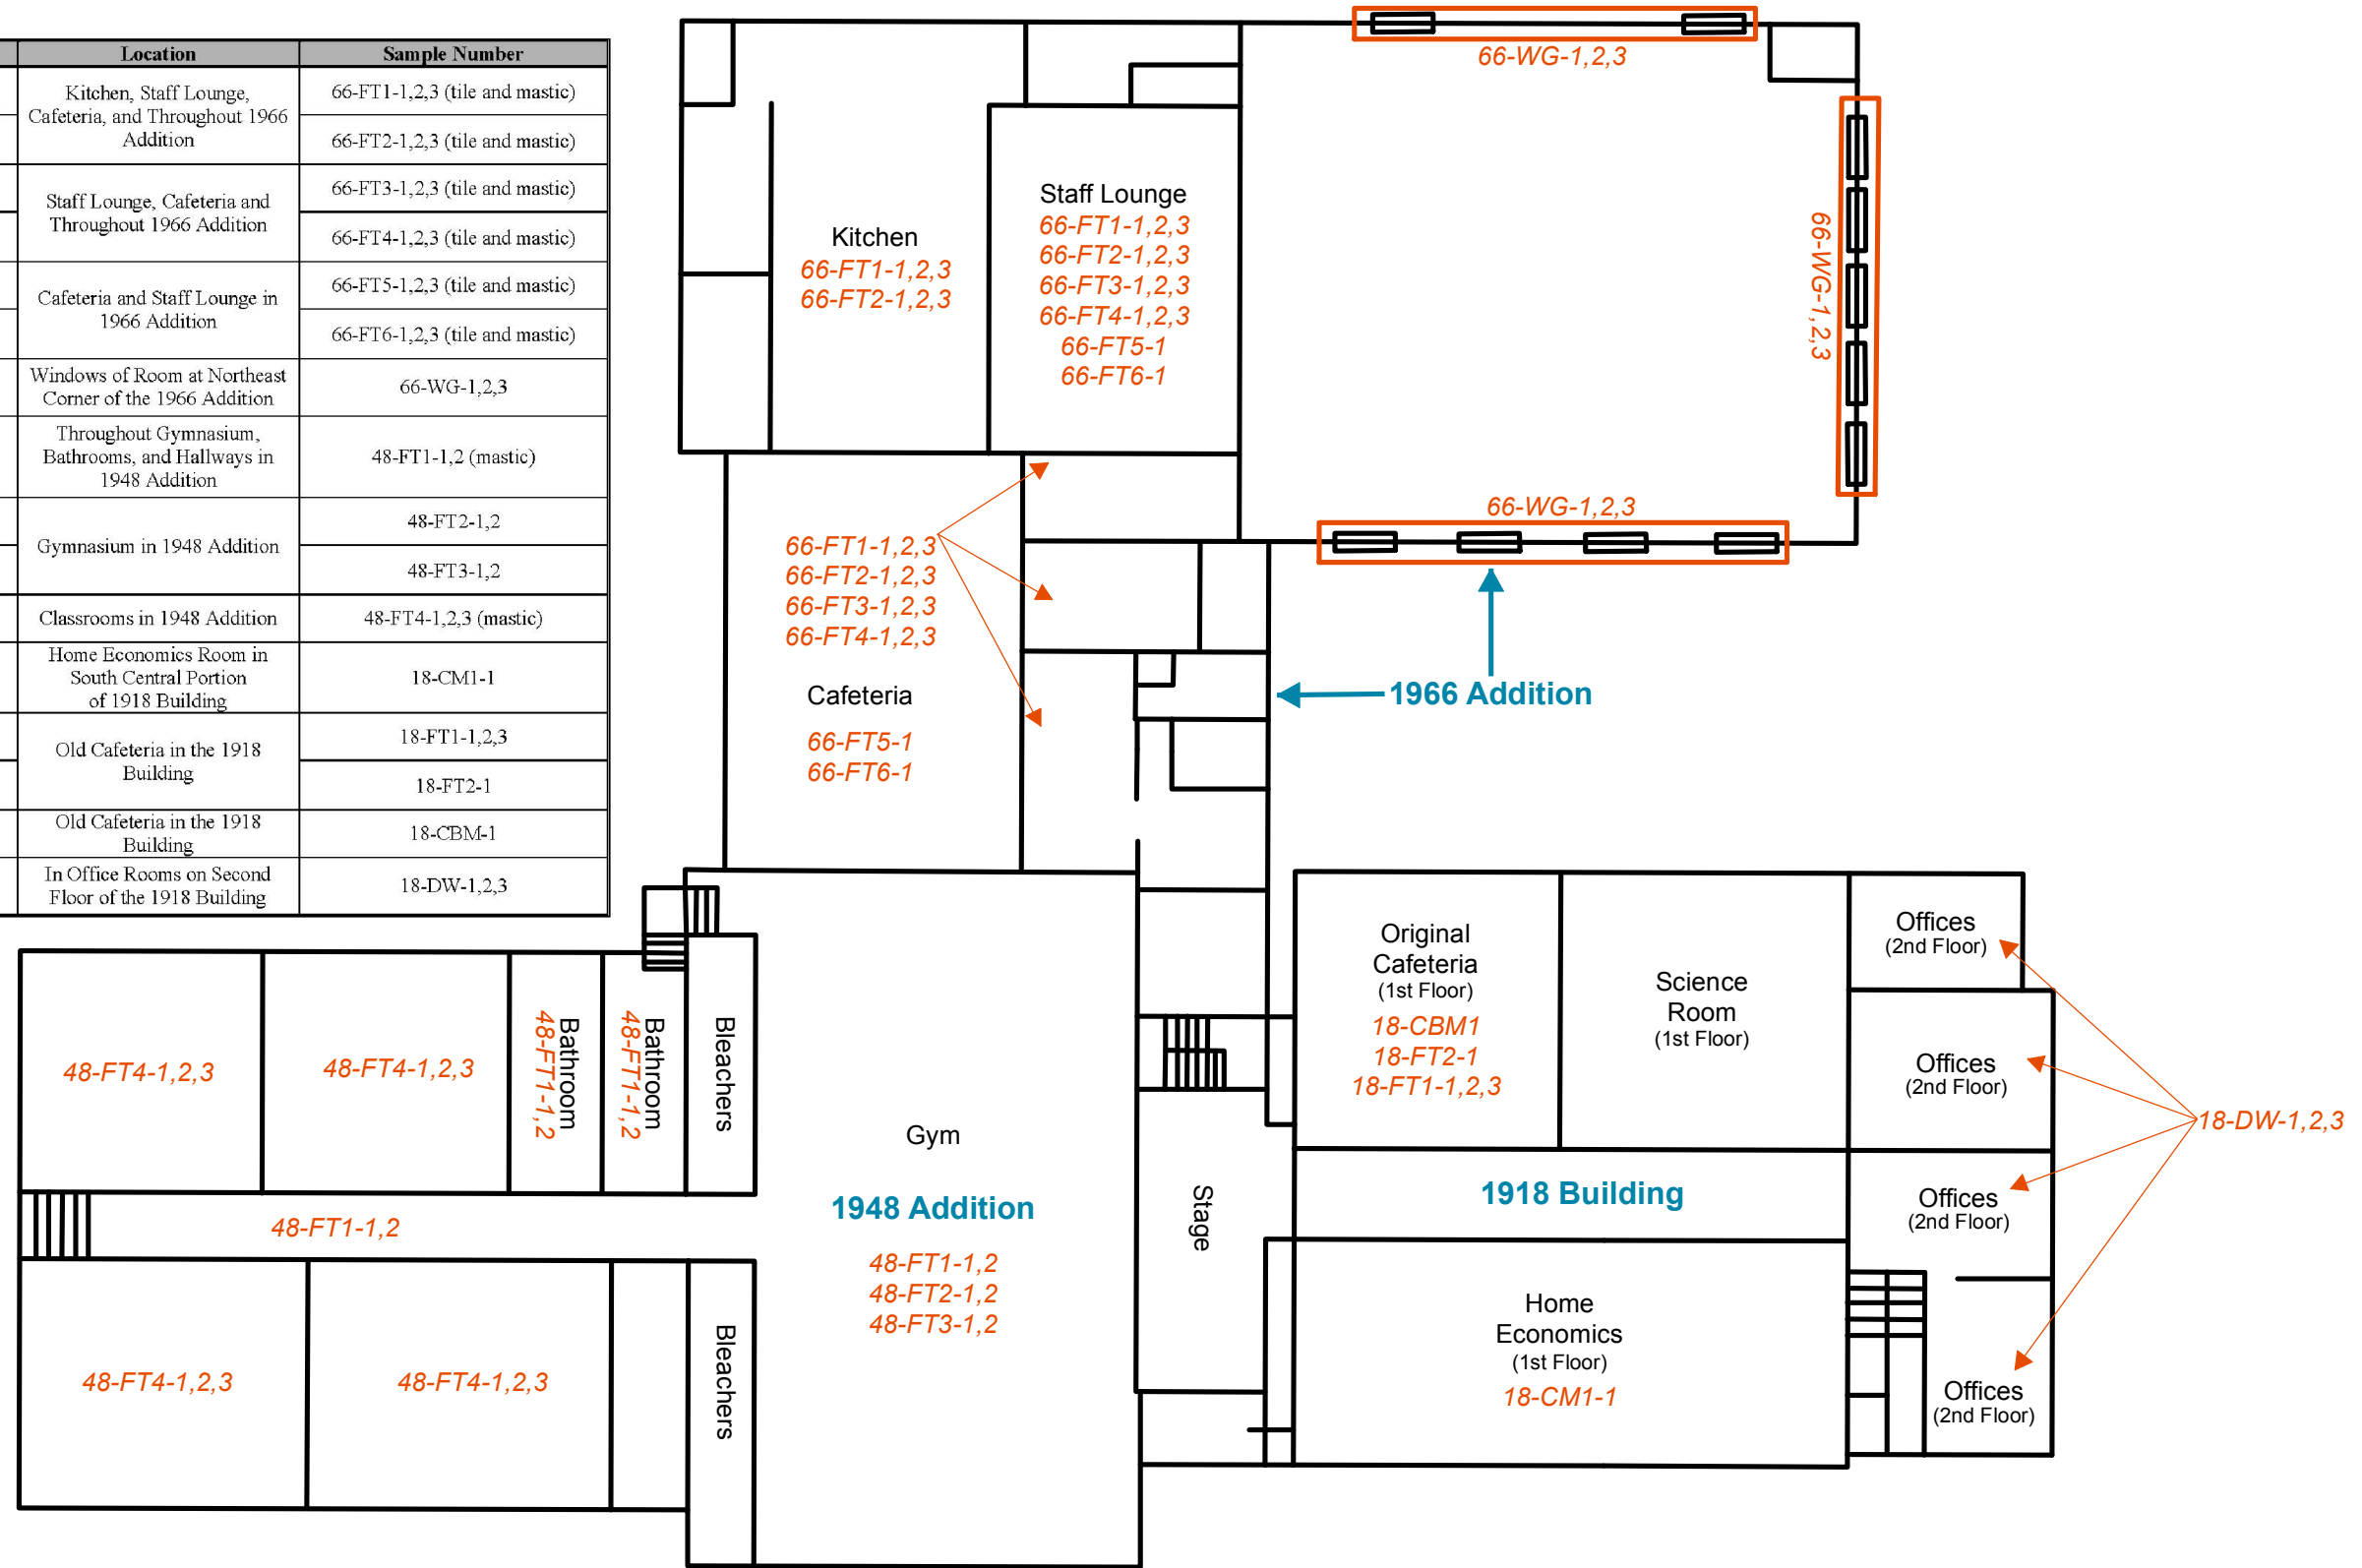
Figure 3  
Asbestos-Containing Materials Location Map  
Mayview School Site  
Mayview, Missouri

Material	Location	Sample Number
Roof Flashing	Chimney of Former School Wood Shop	WS-RF-1,2,3
Roof Flashing	Along Roof Perimeter and at Penetrations of 1966 Addition	66-RF-1,2,3
Asphalt Roofing	On Roof of 1948 Addition	48-AR-1,2,3
Roof Flashing	Along Roof Perimeter and at Penetrations of 1948 Addition	48-RF-1,2,3
Roof Tar	On Roof of 1948 Addition	48-RT-3
Roof Flashing	Along Roof Perimeter and at Penetrations of 1918 Addition	18-RF-1,2

Material	Location	Sample Number
Tan 9"x 9" Vinyl Tile/Mastic	Kitchen, Staff Lounge, Cafeteria, and Throughout 1966 Addition	66-FT1-1,2,3 (tile and mastic)
Brown 9"x 9" Vinyl Tile/Mastic		66-FT2-1,2,3 (tile and mastic)
Beige 9"x 9" Vinyl Tile/Mastic		66-FT3-1,2,3 (tile and mastic)
Gray 9"x 9" Vinyl Tile/Mastic	Staff Lounge, Cafeteria and Throughout 1966 Addition	66-FT4-1,2,3 (tile and mastic)
Yellow 9"x 9" Vinyl Tile/Mastic		66-FT5-1,2,3 (tile and mastic)
Black 9"x 9" Vinyl Tile/Mastic	Cafeteria and Staff Lounge in 1966 Addition	66-FT6-1,2,3 (tile and mastic)
Window Glaze	Windows of Room at Northeast Corner of the 1966 Addition	66-WG-1,2,3
Cream 12"x 12" Vinyl Tile Mastic	Throughout Gymnasium, Bathrooms, and Hallways in 1948 Addition	48-FT1-1,2 (mastic)
Black 2"x 6" Vinyl Tile/Mastic	Gymnasium in 1948 Addition	48-FT2-1,2
Red 1"x 2" Vinyl Tile/Mastic		48-FT3-1,2
Tan 9"x 9" Vinyl Tile/Mastic	Classrooms in 1948 Addition	48-FT4-1,2,3 (mastic)

Carpet Mastic	Home Economics Room in South Central Portion of 1918 Building	18-CM1-1
Dark Green 9"x 9" Vinyl Tile/Mastic	Old Cafeteria in the 1918 Building	18-FT1-1,2,3
Light Green 9"x 9" Vinyl Tile/Mastic		18-FT2-1
Chalkboard Mastic	Old Cafeteria in the 1918 Building	18-CBM-1
Joint Compound	In Office Rooms on Second Floor of the 1918 Building	18-DW-1,2,3

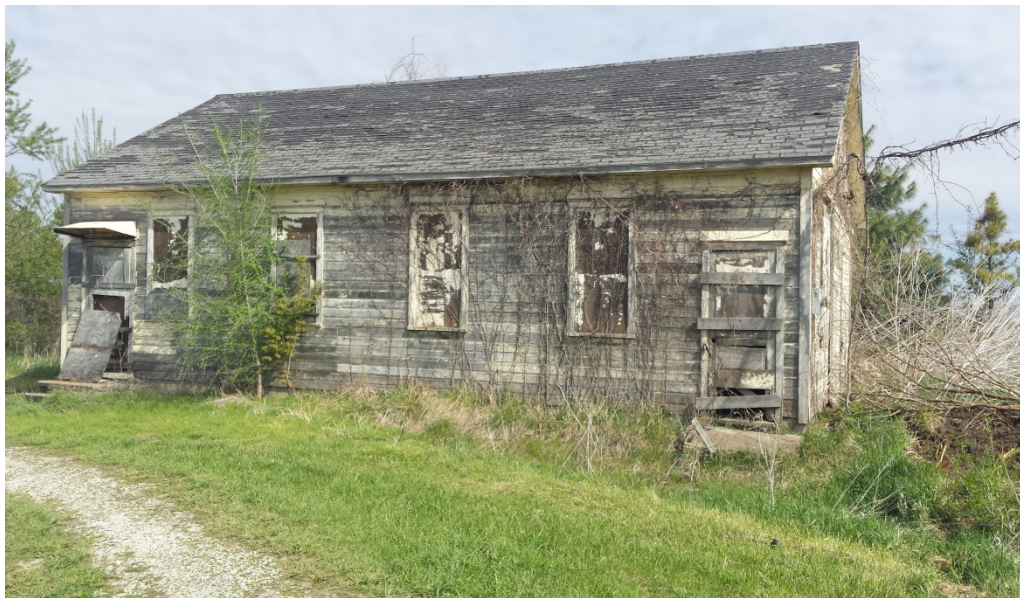
Description: Photograph showing the structure used for the former  
Mayview School wood shop. Asbestos was determined to  
be in the roof flashing around the chimney base.

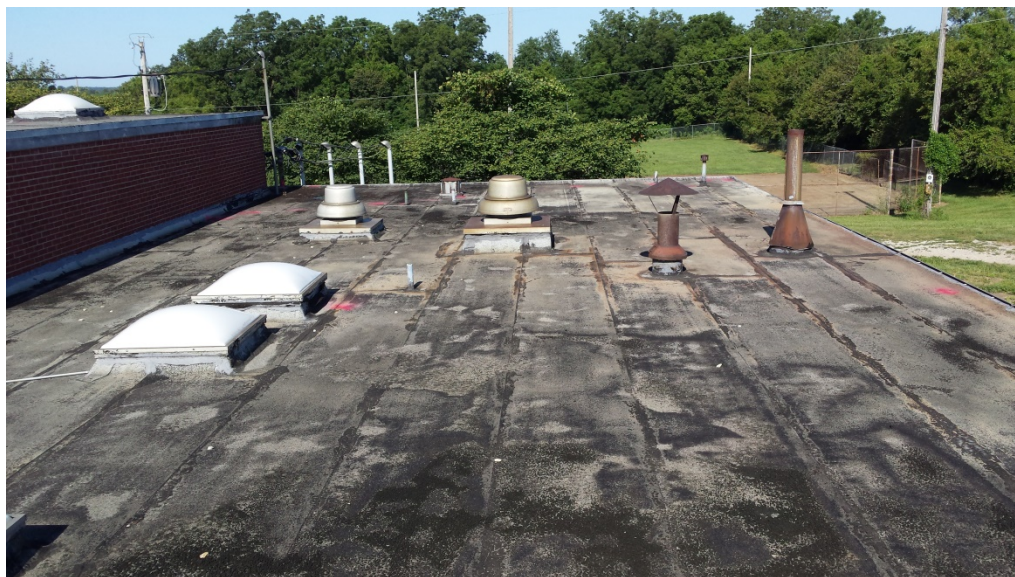
Description: Photograph showing the roof of the 1966 addition, which has roof flashing that was determined to contain asbestos.

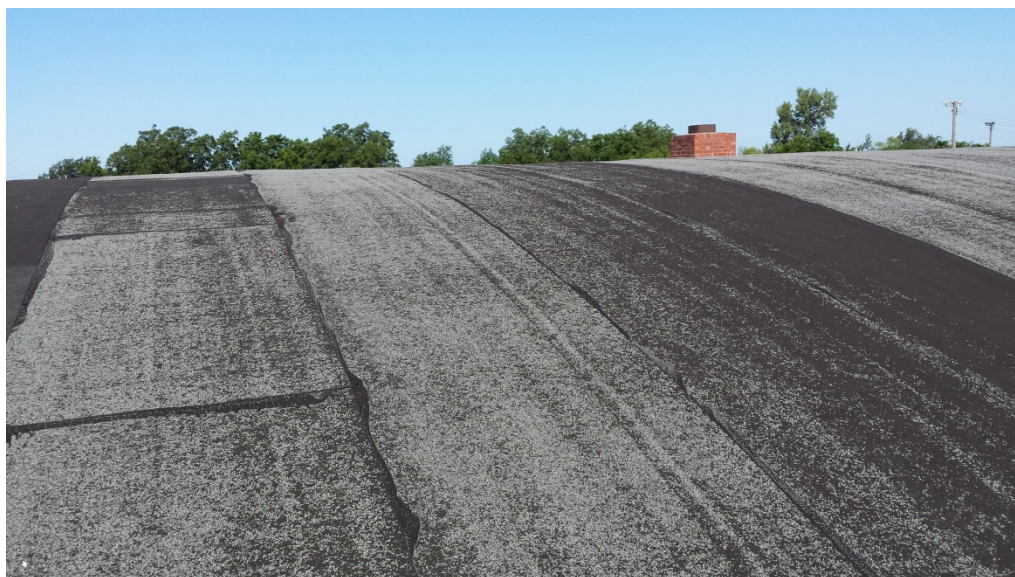
Description: Photograph showing part of the roof on the 1948 addition. Asphalt roofing, tar, and roof flashing samples collected from the roof of the 1948 building addition were determined to contain asbestos.

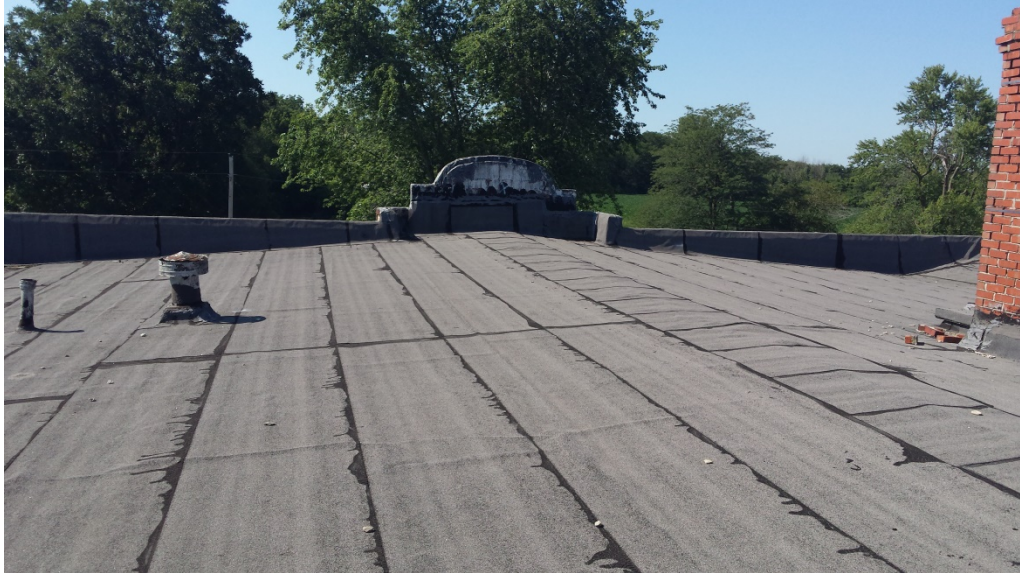
<p>Client: Missouri Department of Natural Resources</p>	<p>Description: Photograph showing the roof of the 1918 building. Laboratory analysis of roof flashing samples collected from the roof were determined to contain asbestos. The roof flashing is along the roof perimeter and at penetrations.</p>	<p>Photograph Number: 5</p>
<p>Direction: South</p>	<p>Photographer: Cosmo Canacari</p>	<p>Date: 8/13/2015</p>

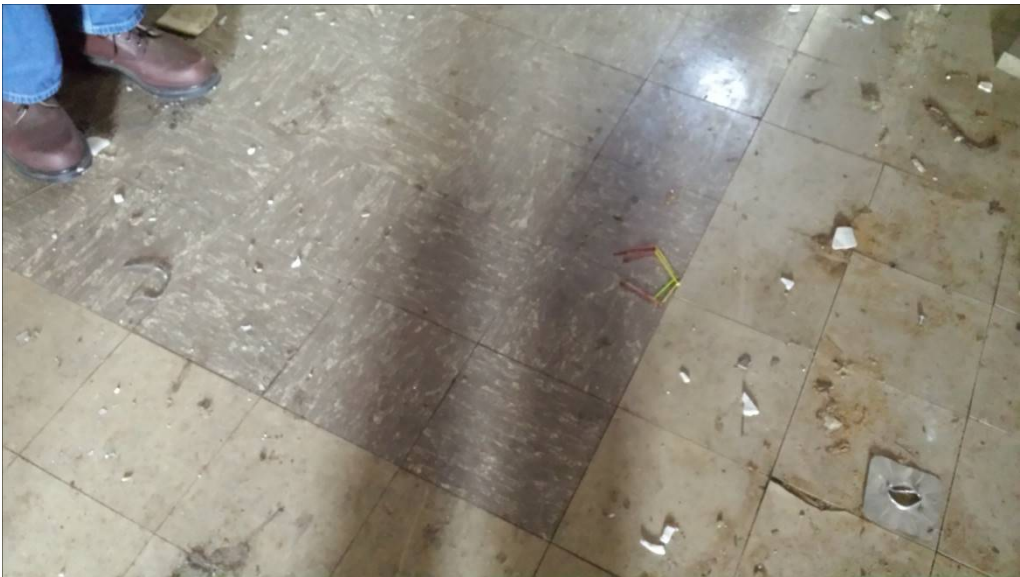
<p>Client: Missouri Department of Natural Resources</p>	<p>Description: Photograph showing tan 9- by 9-inch and brown 9- by 9-inch vinyl floor tile. Those tiles and associated mastic were determined to contain asbestos. They are in the kitchen, staff lounge, cafeteria, and throughout the 1966 addition.</p>	<p>Photograph Number: 6</p>
<p>Direction: N/A</p>	<p>Photographer: Cosmo Canacari</p>	<p>Date: 8/13/2015</p>

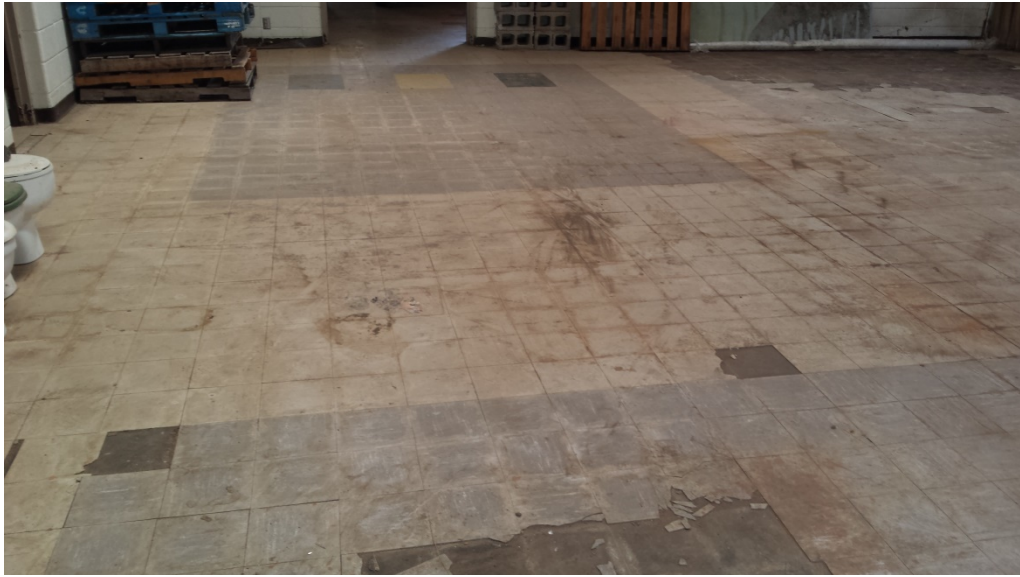
Client: Missouri Department of Natural Resources	Description: Photograph showing beige, gray, black and yellow 9- by 9- inch vinyl floor tiles. All of those floor tiles were determined to contain asbestos. The mastic associated with those tiles (except for the yellow tile) were also determined to contain asbestos.	Photograph Number: 7
Direction: N/A	Photographer: Cosmo Canacari	Date: 8/13/2015

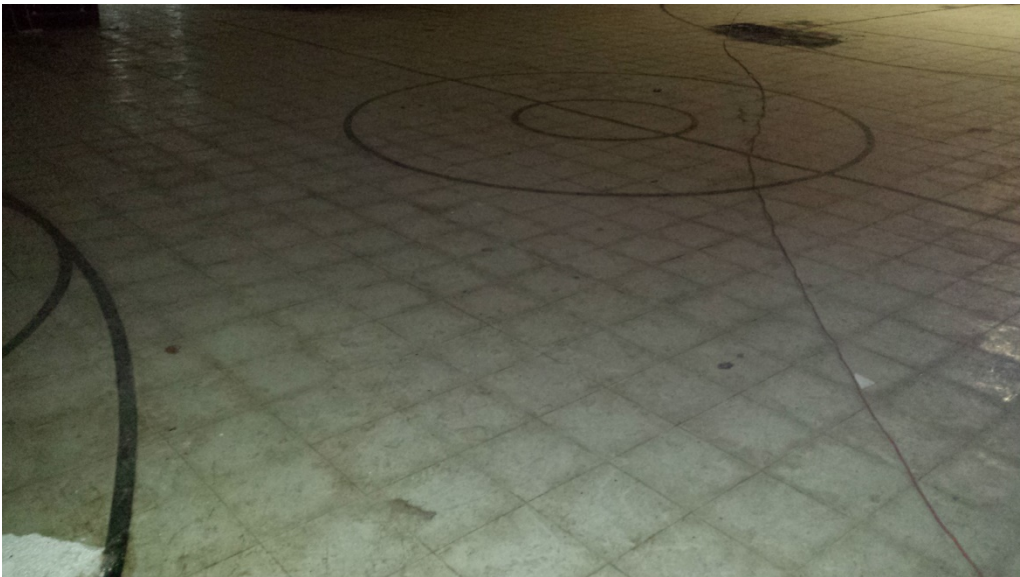
Client: Missouri Department of Natural Resources	Description: Photograph showing cream-colored 9- by 9- inch vinyl floor tile in the gymnasium. Mastic associated with that tile, along with black and red tile in the gymnasium were determined to contain asbestos.	Photograph Number: 8
Direction: N/A	Photographer: Cosmo Canacari	Date: 8/13/2015

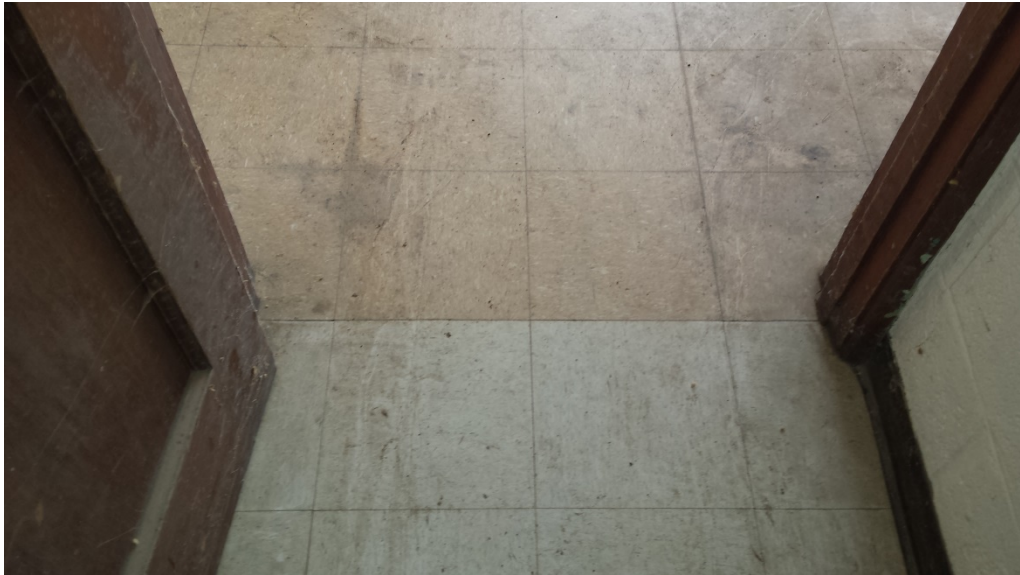
Client: Missouri Department of Natural Resources	Description: Photograph showing tan 9- by 9-inch vinyl floor tile in the classrooms of the 1948 addition. The mastic associated with that tile was determined to contain asbestos.	Photograph Number: 9
Direction: West	Photographer: Cosmo Canacari	Date: 8/13/2015

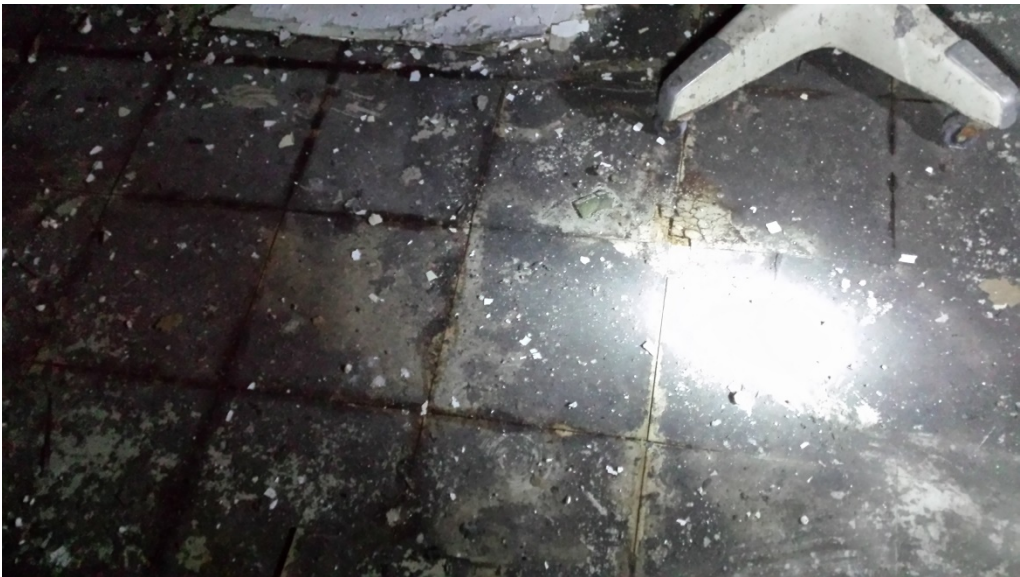
Client: Missouri Department of Natural Resources	Description: Photograph showing green 9- by 9-inch vinyl floor tile in the old cafeteria of the 1918 building. That tile and a light green 9- by 9-inch vinyl floor tile and associated mastic were determined to contain asbestos.	Photograph Number: 10
Direction: N/A	Photographer: Cosmo Canacari	Date: 8/13/2015

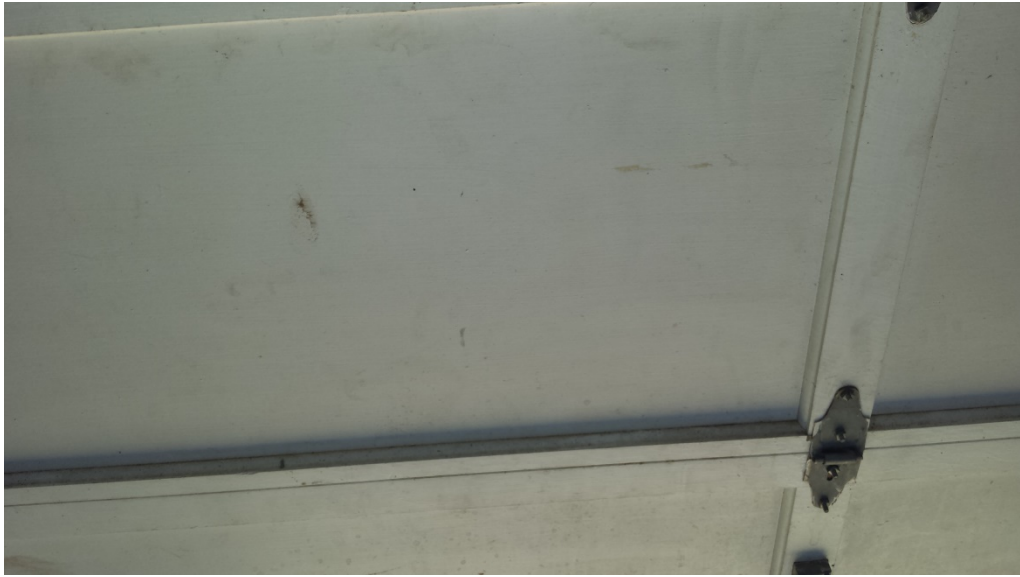
Client: Missouri Department of Natural Resources	Description: Photograph showing the white painted surface of a garage door that was determined to contain lead-based paint (LBP).	Photograph Number: 11
Direction: N/A	Photographer: Cosmo Canacari	Date: 8/13/2015

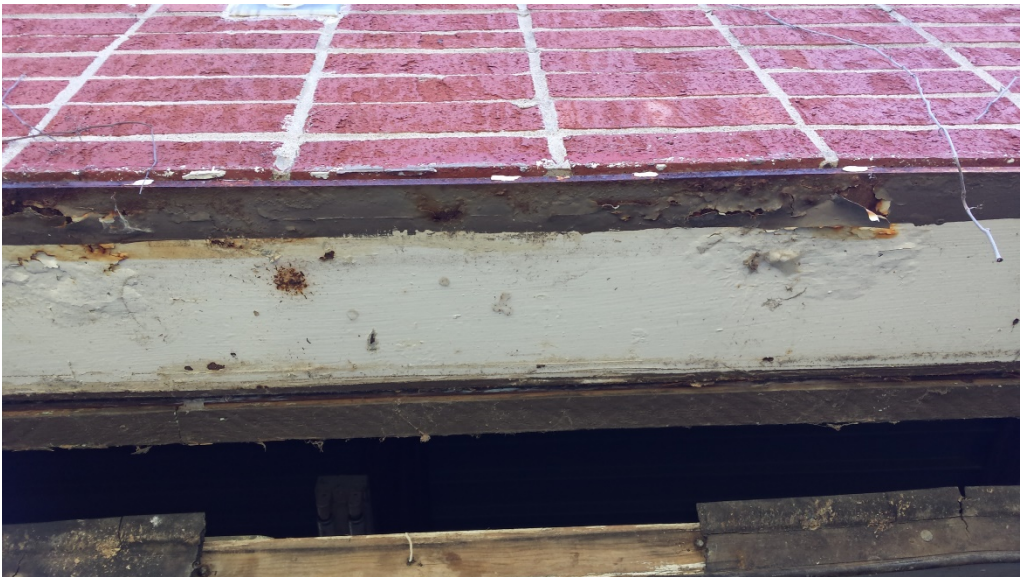
Client: Missouri Department of Natural Resources	Description: Photograph of the metal garage door header determined to contain LBP.	Photograph Number: 12
Direction: N/A	Photographer: Cosmo Canacari	Date: 8/13/2015

For this site, chemical stripping is a viable option for the structural components (step risers on stairs and metal garage door header).
