ANALYSIS OF BROWNFIELDS CLEANUP ALTERNATIVES

**Old Saw Shop
835 Highway 42
Iberia, MO 65486**

PE Project No. 016.03.003

Analysis of Brownfields Cleanup Alternatives
Old Saw Shop, 835 Highway 42, Iberia, Missouri 65486
Prepared by Professional Environmental Engineers, Inc. (PE)
For the City of Iberia

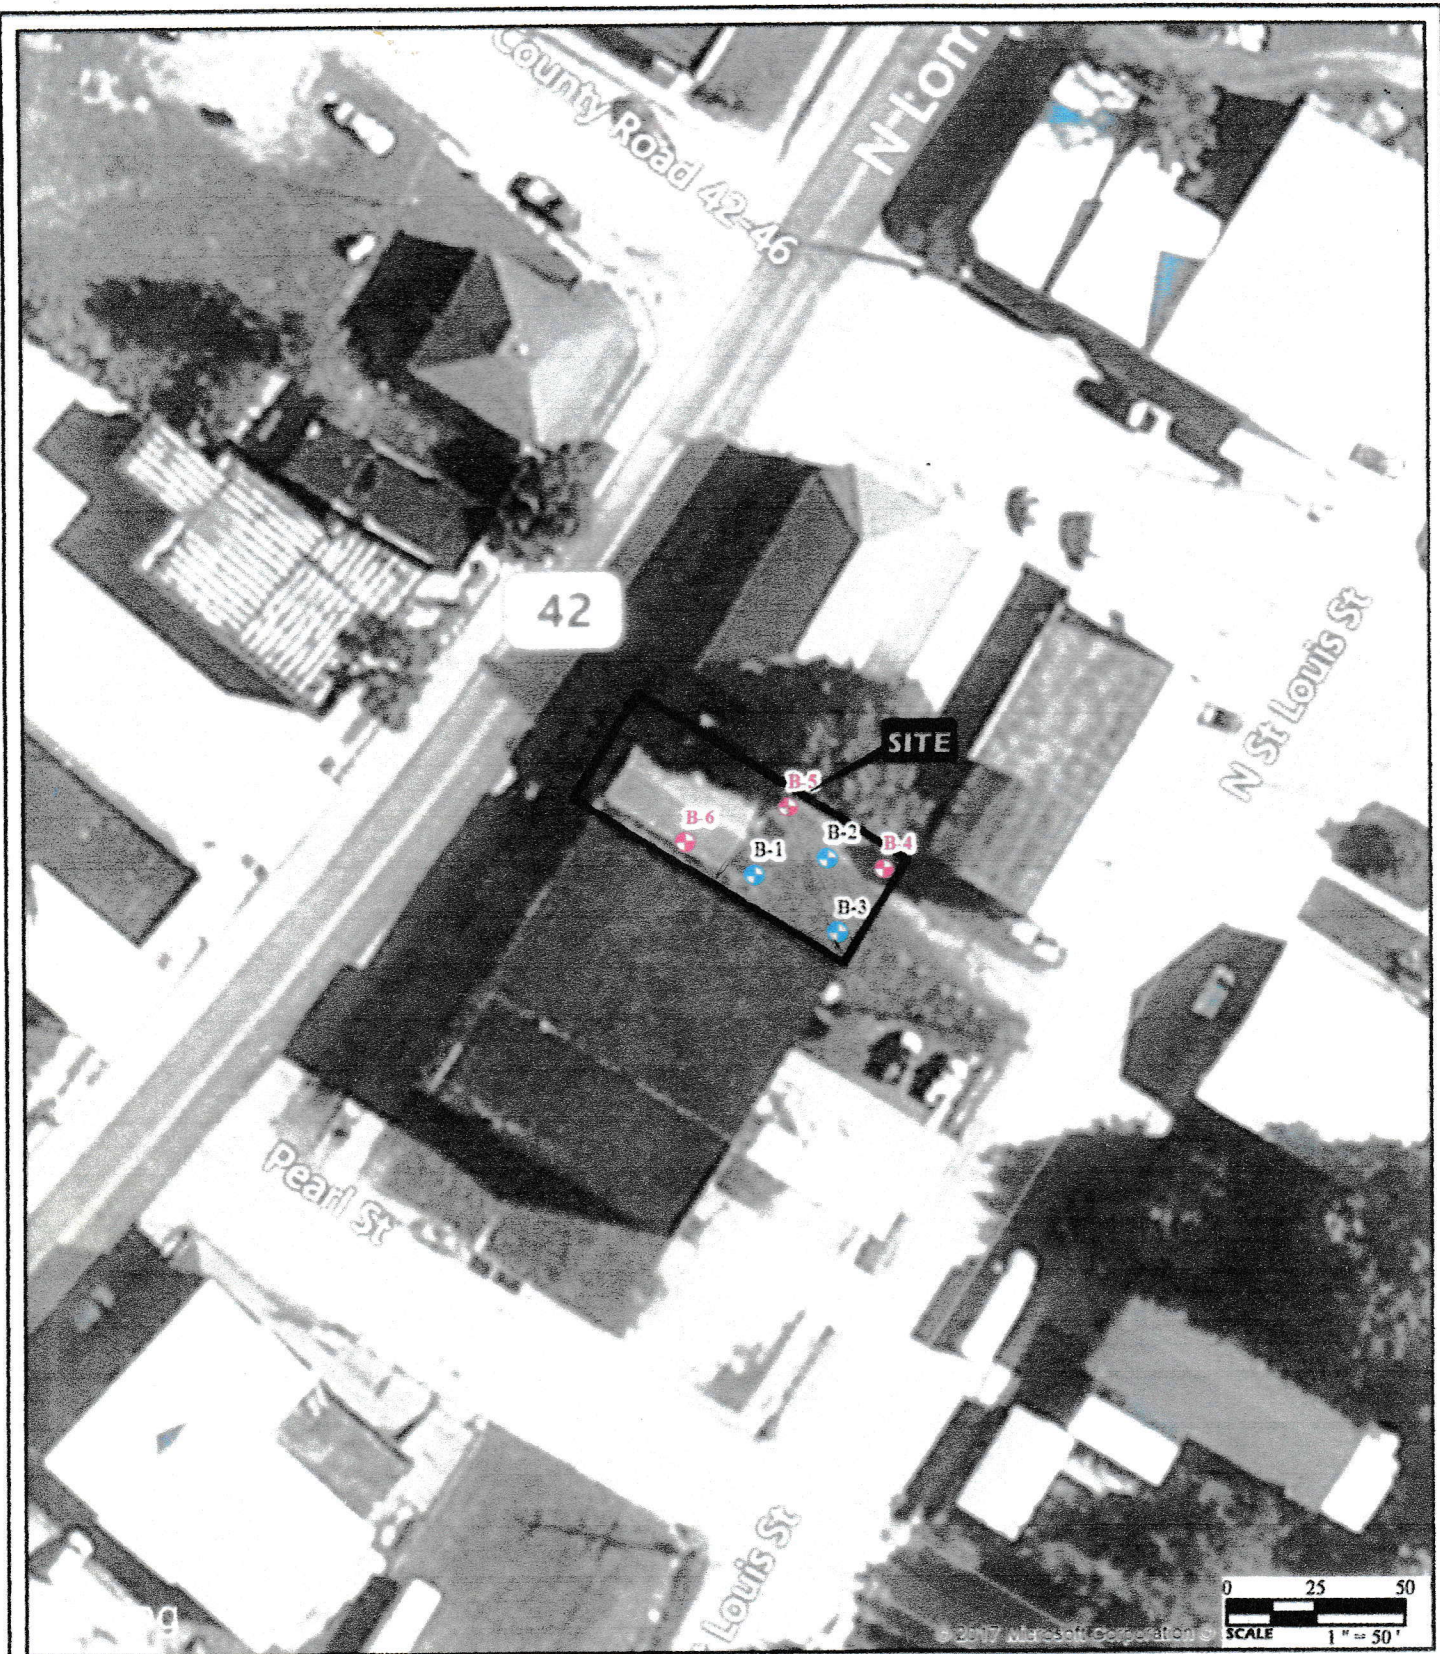
FIGURE
 1

approximate 2-foot-vertical intervals using a photoionization detector (PID).with readings ranging from 2.9 to 7.9 parts per million (ppm). Temporary piezometers were installed in each boring in order to collect groundwater samples. Only the piezometers at boring B-1 and B-4 yielded enough water to sample. After collecting the groundwater sample, all temporary piezometers were abandoned. Soil and groundwater samples were analyzed for Resource Conservation and Recovery Act (RCRA) 8 metals (which included arsenic, barium, cadmium, chromium, lead, mercury, selenium, and silver) and polynuclear aromatic hydrocarbons (PAHs). SCI compared soil and groundwater analytical results to Missouri Department of Natural Resources (MDNR) Default Target Levels (DTLs) and background metal concentrations for Miller County (SCI, 2017); MDNR DTLs are the most conservative target levels established by the state and are based on unrestricted land use. A figure showing soil boring and groundwater piezometer locations is provided as Attachment 1.

**BORING LOCATIONS MAP &
 AERIAL PHOTOGRAPH**

- INDICATES APPROXIMATE SOIL BORING LOCATIONS.
- INDICATES PREVIOUS SOIL BORING LOCATIONS, DRILLED 07/2016.

Limited Phase II ESAs were conducted by SCI Engineering, Inc. (SCI), in July 2016 and June 2017 to investigate potential impact to on-site soil and groundwater. SCI advanced six soil borings at the site (B-1 through B-6). The borings extended to a depth of 8 feet (ft) below ground surface (bgs), at which point they encountered refusal on bedrock. The soils were screened on

Five soil samples exceeded the background concentration for lead, which is 41.75 milligrams per kilogram (mg/kg) based on the maximum background concentrations in Miller County (SCI, 2017). These samples included B-1 (0-2 ft bgs) at 1,040 mg/kg, B-2 (0-2 ft bgs) at 202 mg/kg, B-2 (4-6 ft bgs) at 132 mg/kg, B-3 (0-2 ft bgs) at 1,180 mg/kg, and B-4 (0-3 ft bgs) at 84.2 mg/kg.

Five soil samples exceeded the background concentration for arsenic, which is 7.57 mg/kg based on the maximum background concentrations in Miller County (SCI, 2017). These include B-4 (0-3 ft bgs) at 8.56 mg/kg, B-4 (6-8 ft bgs) at 14.7 mg/kg, B-5 (0-3 ft bgs) at 10 mg/kg, B-5 (4-6 ft bgs) at 12.9 mg/kg, and B-6 (4-6 ft bgs) at 14.9 mg/kg. All analytical results for soil samples are included in Table 1 in Attachment 2.
